SAFETY LETTER

Spezielle Vorflugkontrollen für Robinson Heckrotorspitze

R22 SB-120

SPECIAL TAIL ROTOR TIP PREFLIGHT INSPECTION

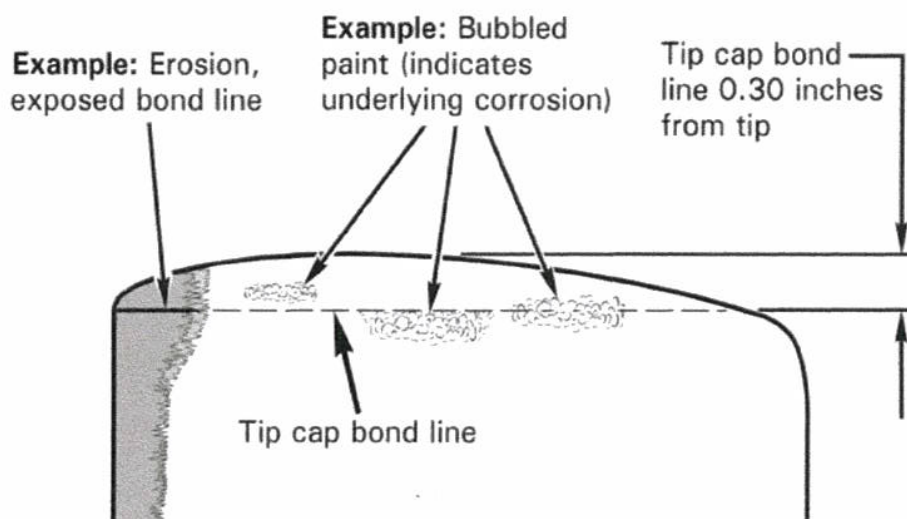
Refer to Figure below.

To be performed before the first flight of each day. May be performed by pilot or mechanic. Conduct visual inspection of tail rotor tip area. If bubbled paint or other evidence of corrosion is observed at or adjacent to tip cap bond line or if any portion of tip cap bond line is exposed, do not fly helicopter. Comply with latest revision of R22 SL-93 prior to further flight.

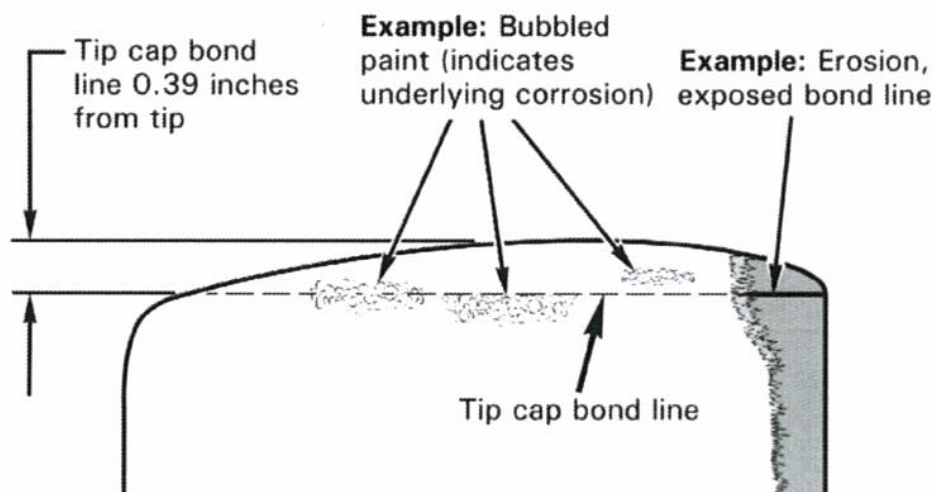
Refer to Figure below.

To be performed before the first flight of each day. May be performed by pilot or mechanic. Conduct visual inspection of tail rotor tip area. If bubbled paint or other evidence of corrosion is observed at or adjacent to tip cap bond line or if any portion of tip cap bond line is exposed, do not fly helicopter. Comply with latest revision of R44 SL-82 prior to further flight.

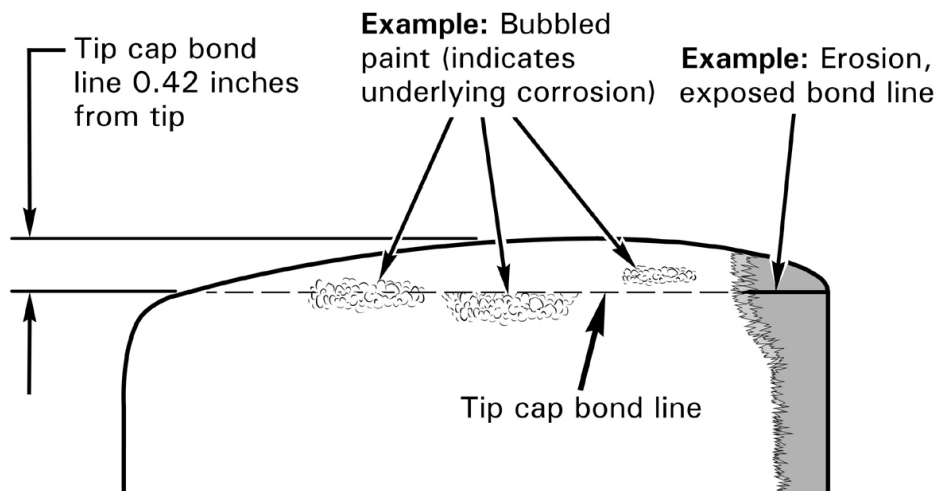
Refer to Figure below.

To be performed before the first flight of each day. May be performed by pilot or mechanic. Conduct visual inspection of tail rotor tip area. If bubbled paint or other evidence of corrosion is observed at or adjacent to tip cap bond line or if any portion of tip cap bond line is exposed, do not fly helicopter. Comply with latest revision of R66 SL-40 prior to further flight.
